BC HYDRO OPERATIONS - ICE OBSERVATION REPORT 34

Flight: Tuesday March 13, 2007

Report: March 14, 2007

Report by Dale Bairstow, Deb Bisson and Martin Jasek

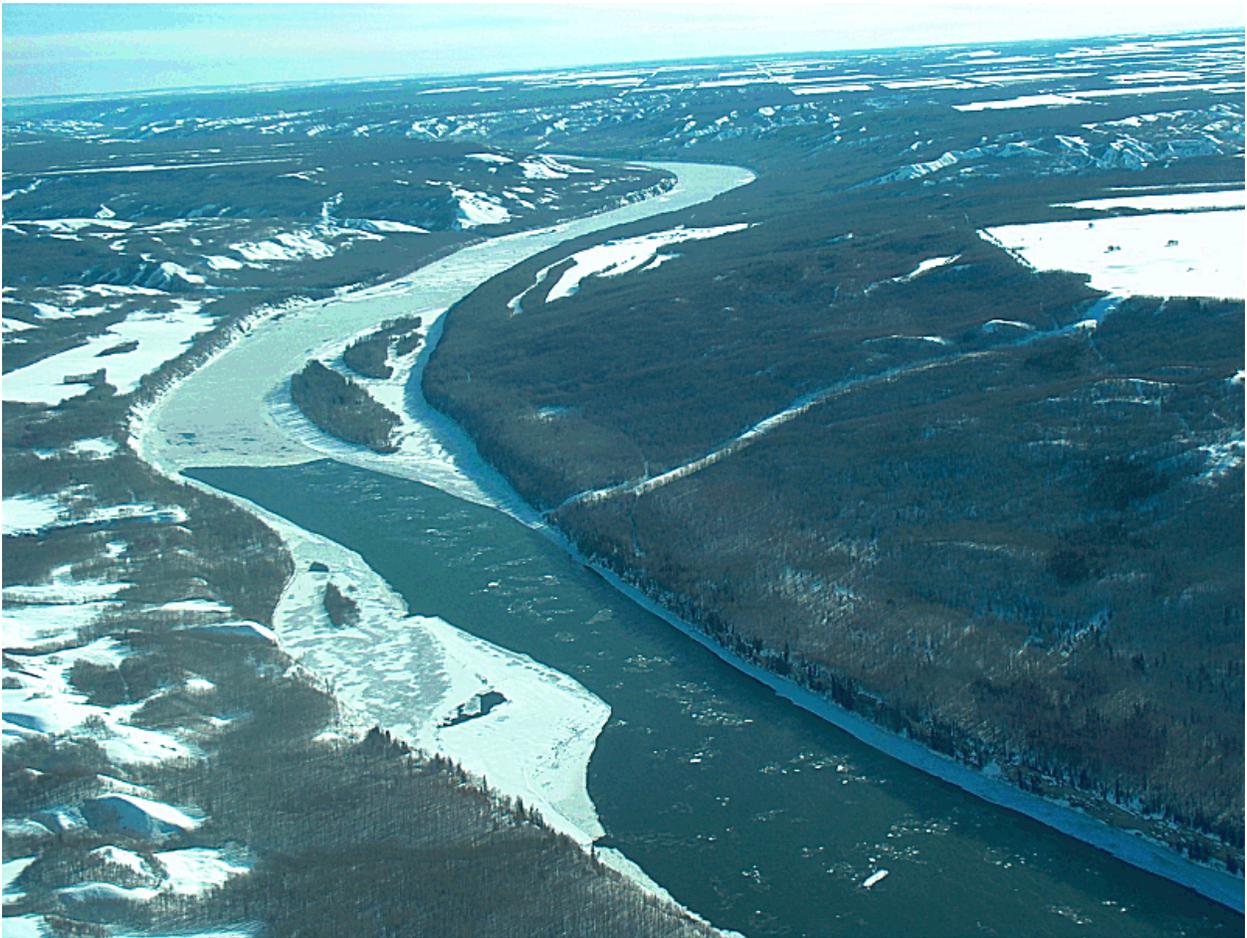
Looking downstream at ice front at km 183.7. Dark floes in foreground are released anchor ice. Brownish colour is due to gravel being carried by the anchor ice. The white floes are broken off shore ice.

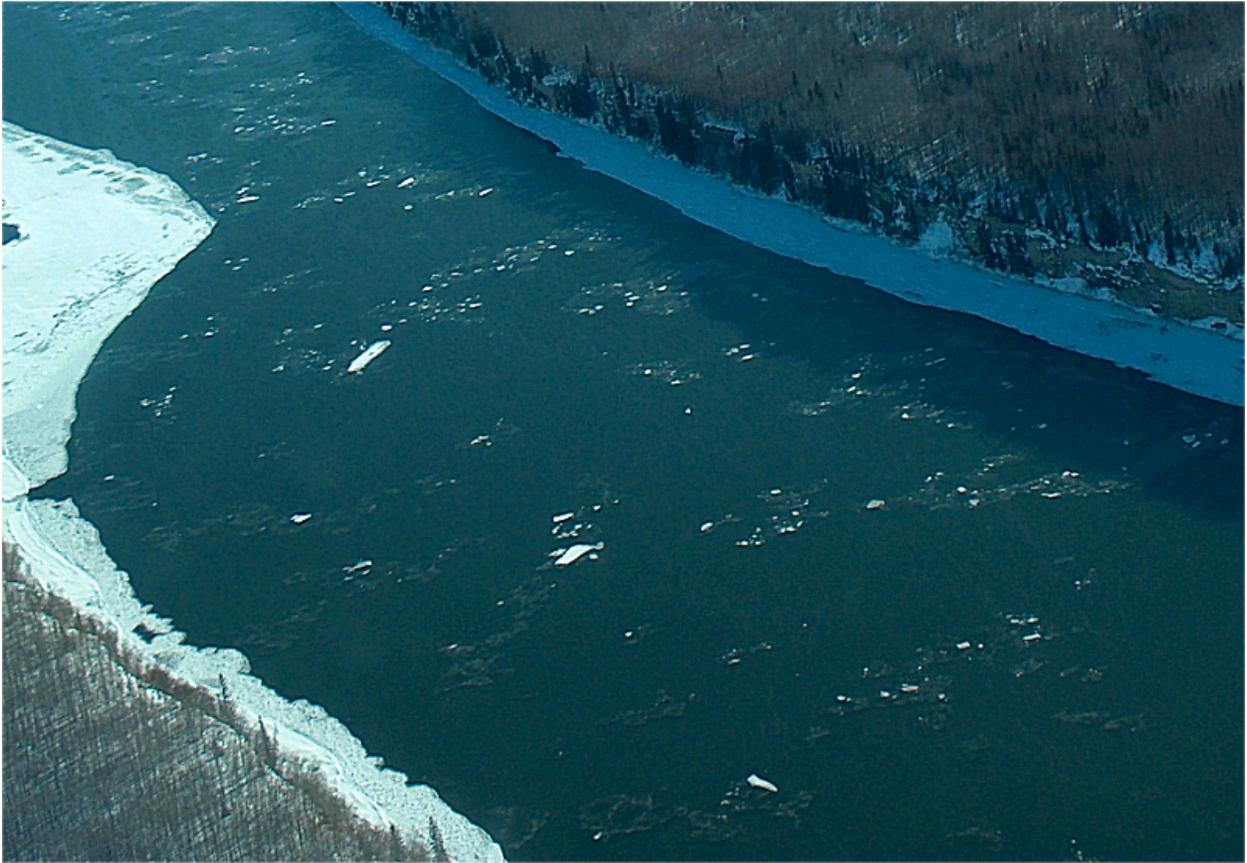
Released anchor ice floes (dark floes) and shore ice floes (white) at km 182 about 3 km upstream of the ice front (flow direction is lower right to upper left)

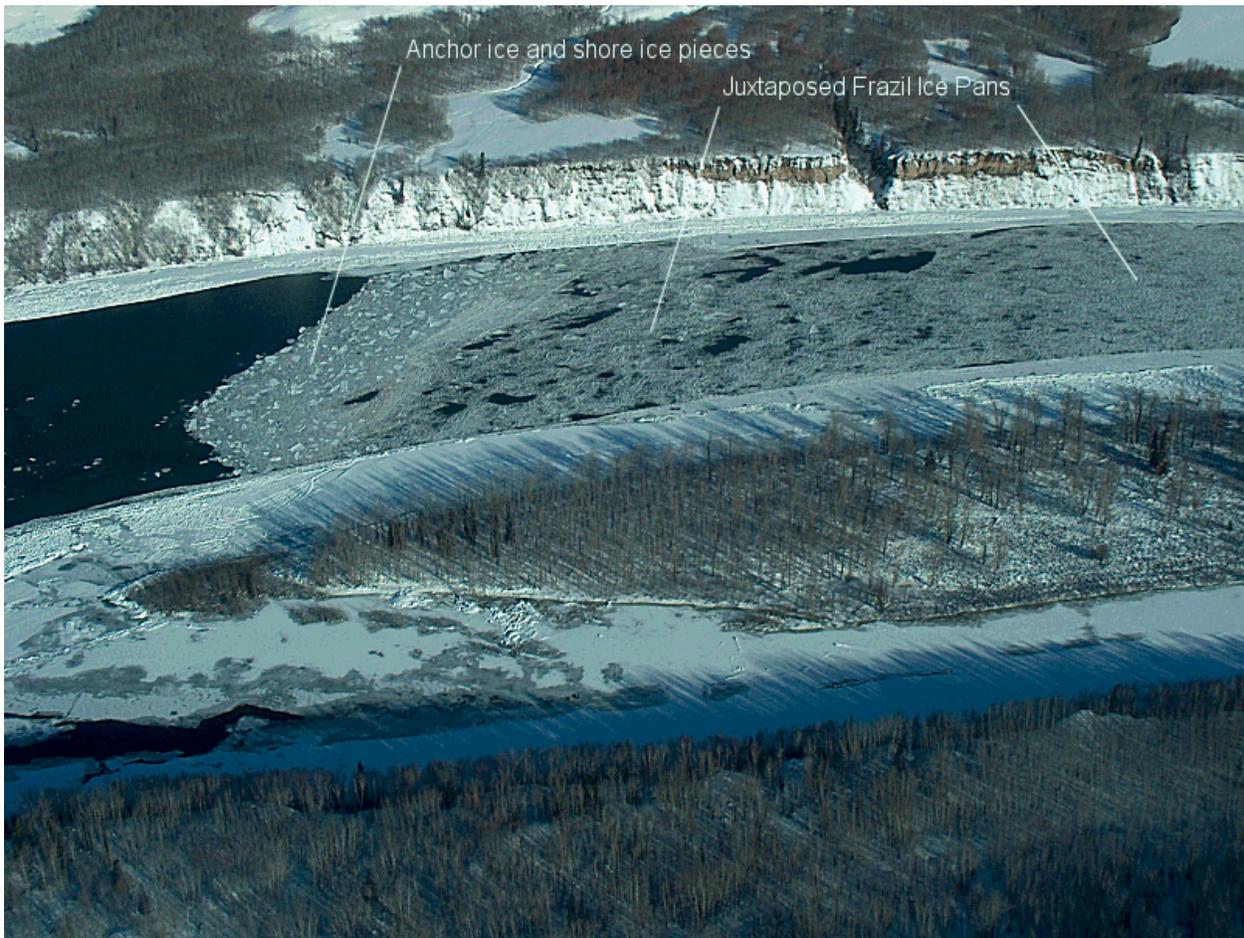
Ice front at km 183.7. (flow is from left to right). Dark anchor ice floes were arriving at the ice front causing the ice cover to advance. This was due to the anchor ice being released from the river bed due to warm temperatures and bright sunshine. This mechanism of ice cover advancement had been occurring for a short while since this ice cover type was only about 50 m long. Once the anchor ice arrives at the ice front it loses its dark colouring since it gets buoyed up by additional floes from underneath which drains the ice giving it a higher albedo. The anchor ice floes upstream of the ice front look dark because the gravel weighing them down causes most of the ice to be submerged making only the gravel visible. Downstream of the anchor ice cover the ice cover was a juxtaposed consisting of frazil pans that formed during the cooler weather on previous days and nights.

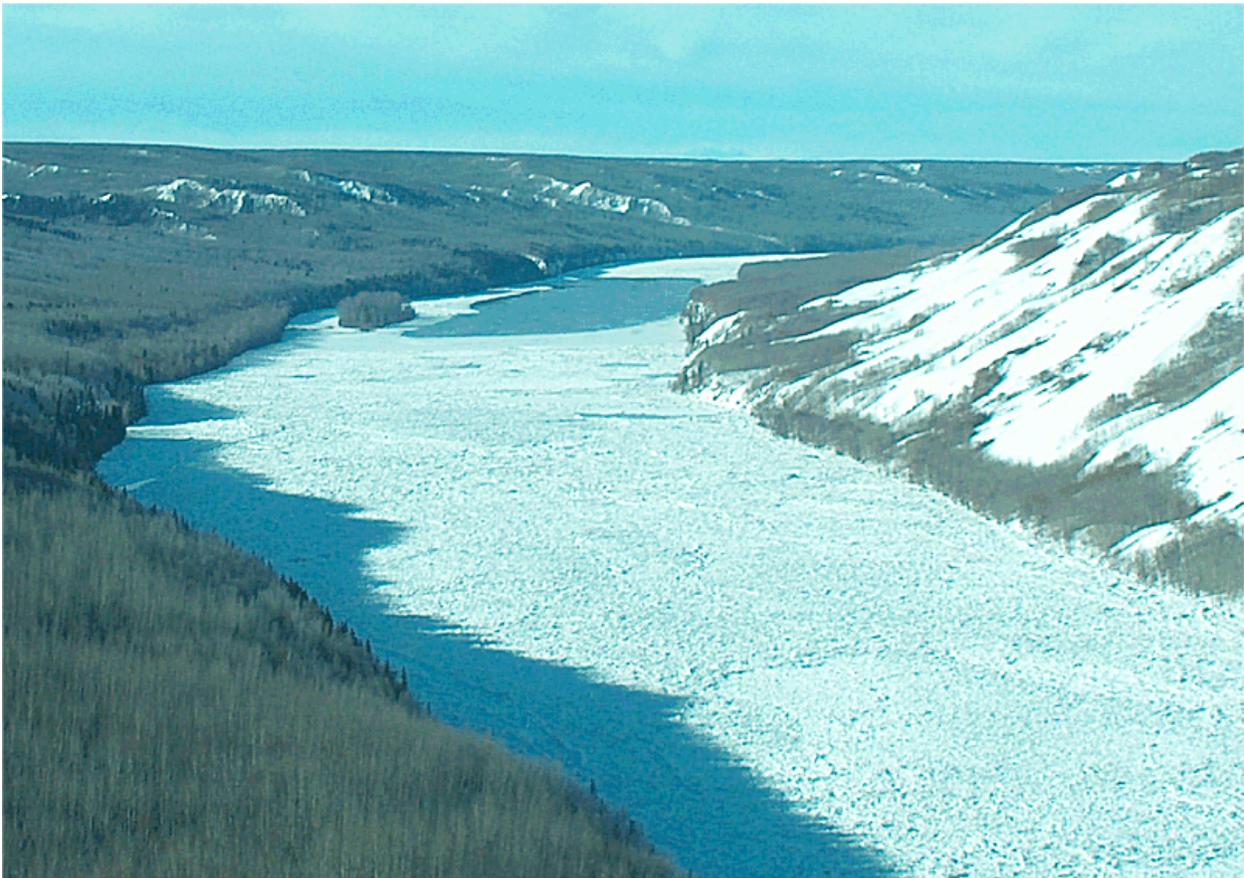
Open water lead from km 193 to 196 (looking upstream) has started to freeze in from the sides.

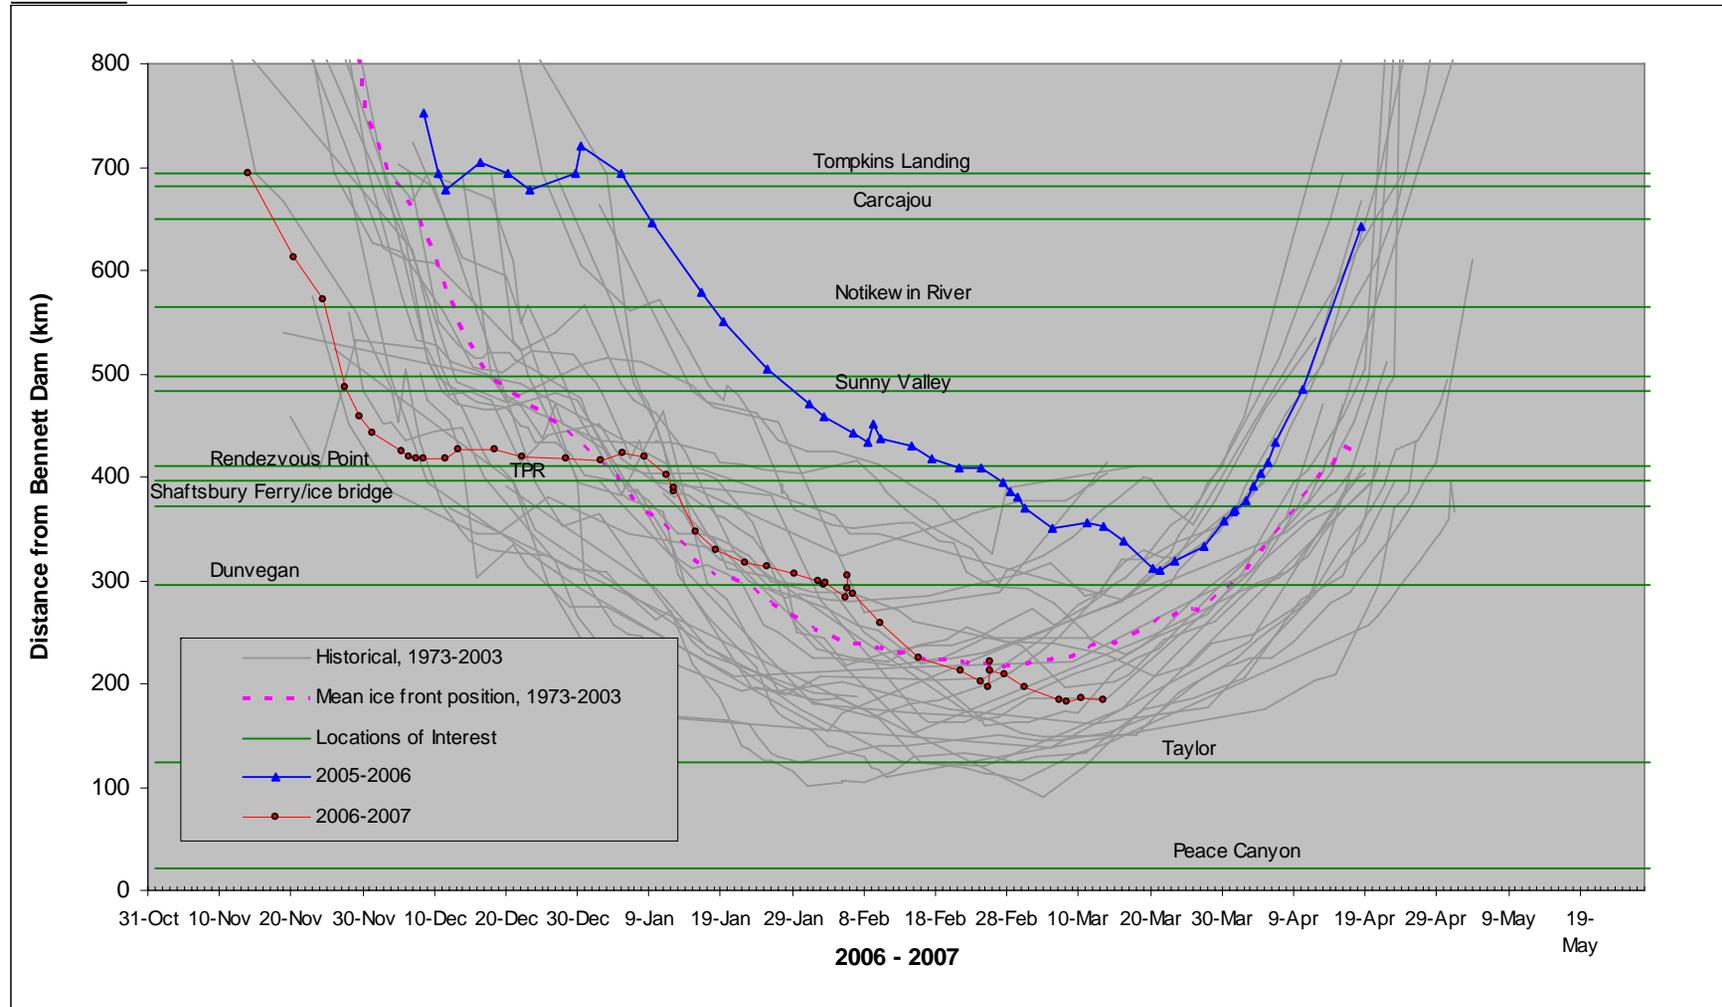
Ice Front

Location of the Ice Front: The ice front had advanced 2.7 km upstream since the last observation on March 10 and was located at **km 183.7 on Mar 13, 2007, 10:00 MDT**. This was approximately 112 km upstream of Dunvegan or about 20 km downstream of the Clayhurst Bridge near the BC/AB border. The advance rate of the ice front between the last two observations was about 0.9 km/day. Since the last flight, daily low temperatures at the Fort. St. John Airport have been about -17 °C with daily highs anywhere from -12 to 0 °C

Given the weather forecast, the ice front is not expected to move much over the next several days. Therefore, the next ice observation flight is scheduled for Monday March 19, 2007 instead of later this week.
