BC HYDRO OPERATIONS - ICE OBSERVATION REPORT 38

Flight: Friday April 6, 2007
Report: April 10, 2007
Report by Dale Bairstow and Martin Jasek

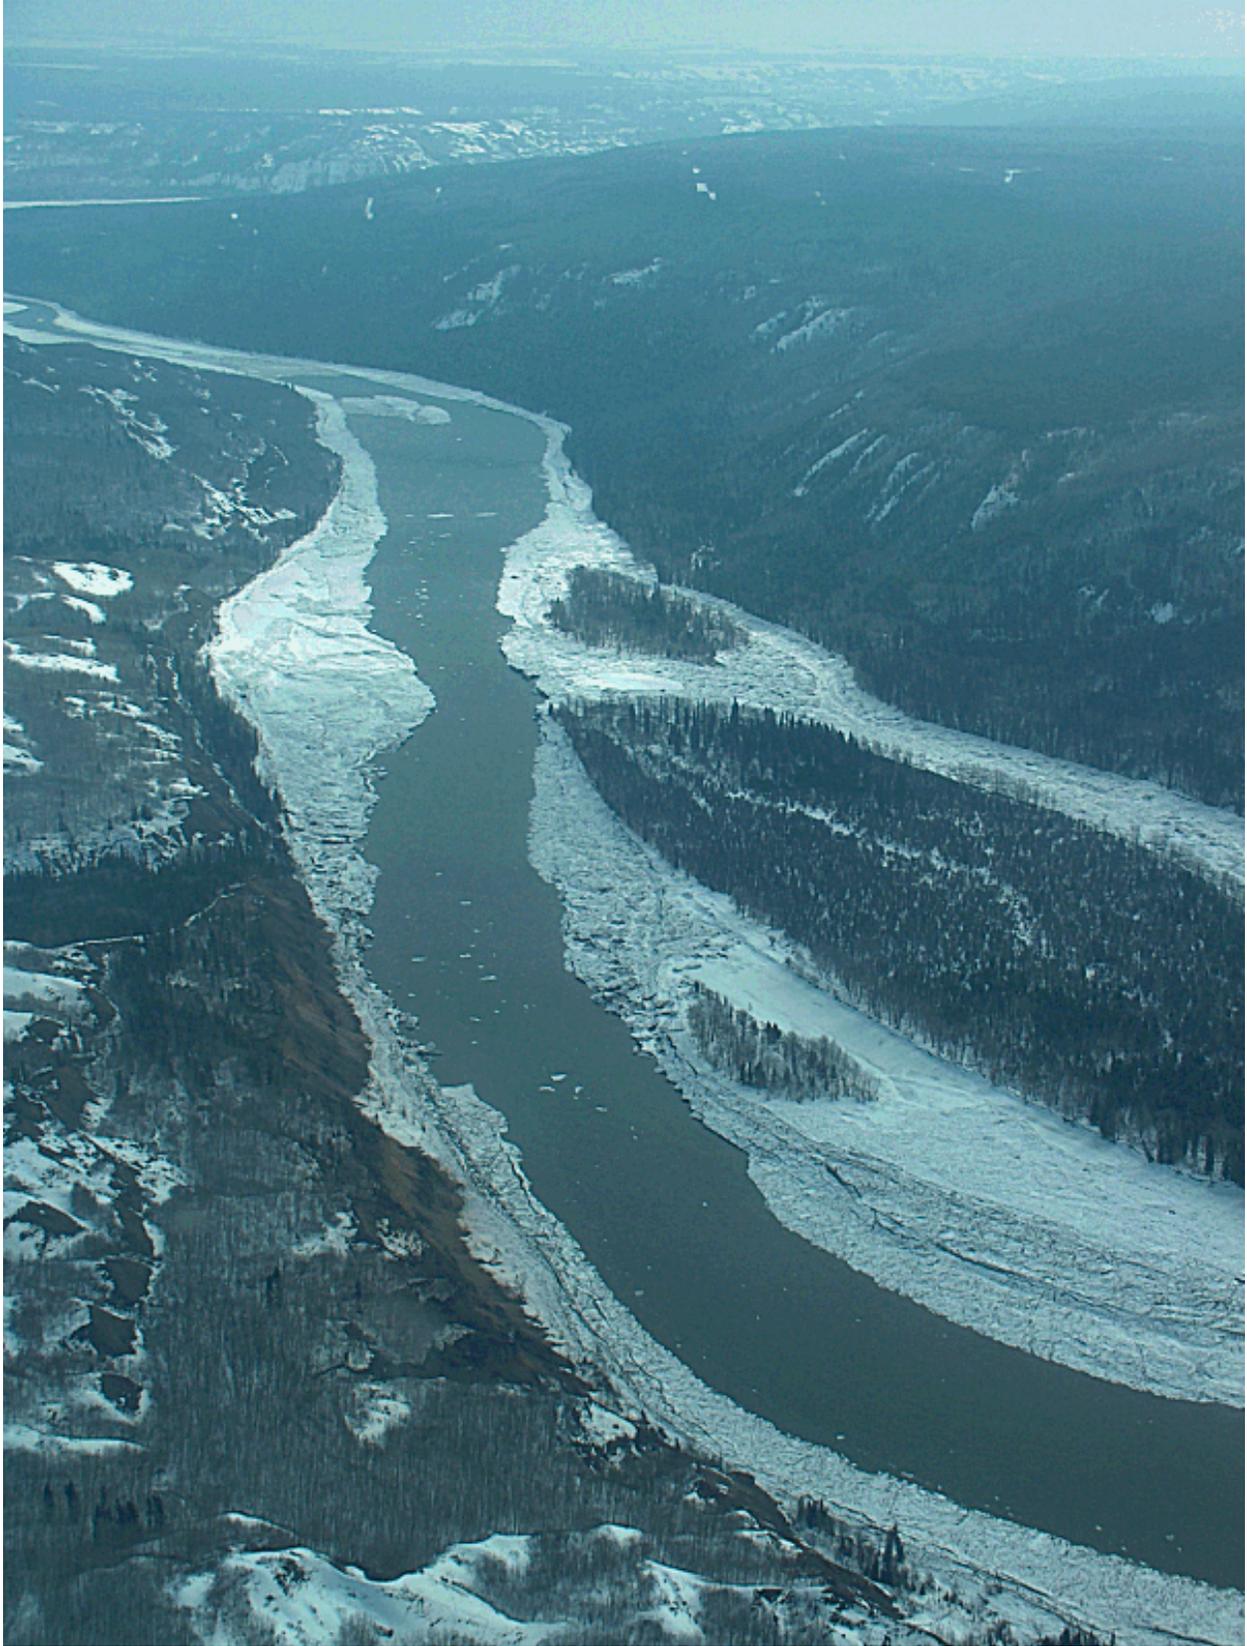
Shore ice upstream of the ice front at km 219. (Looking downstream).

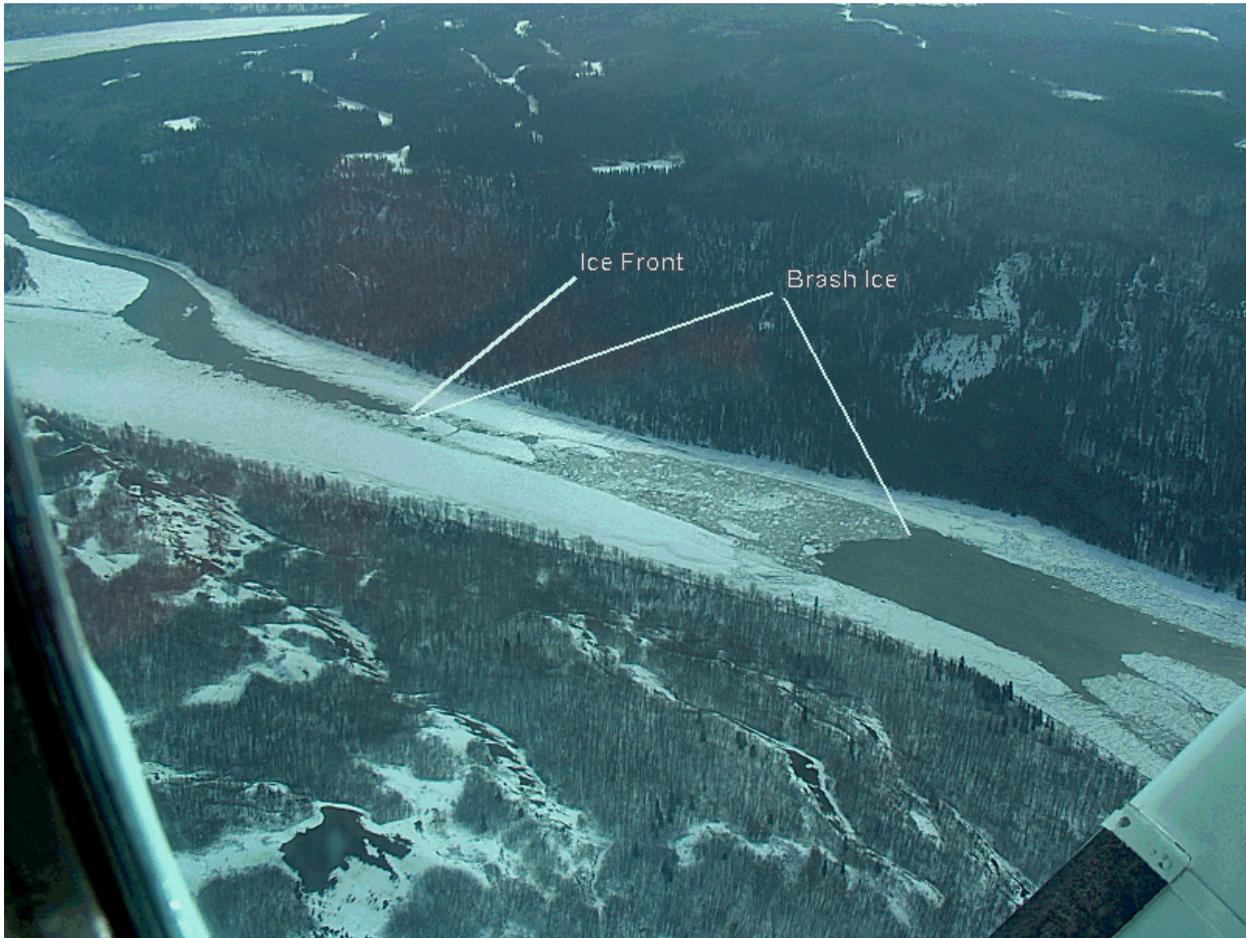
Ice front at km 223.5 and upstream end of brash ice at km 223.2. (Flow is right to left). Lead starting immediately downstream of ice front and continuing downstream into right channel at Many Islands.

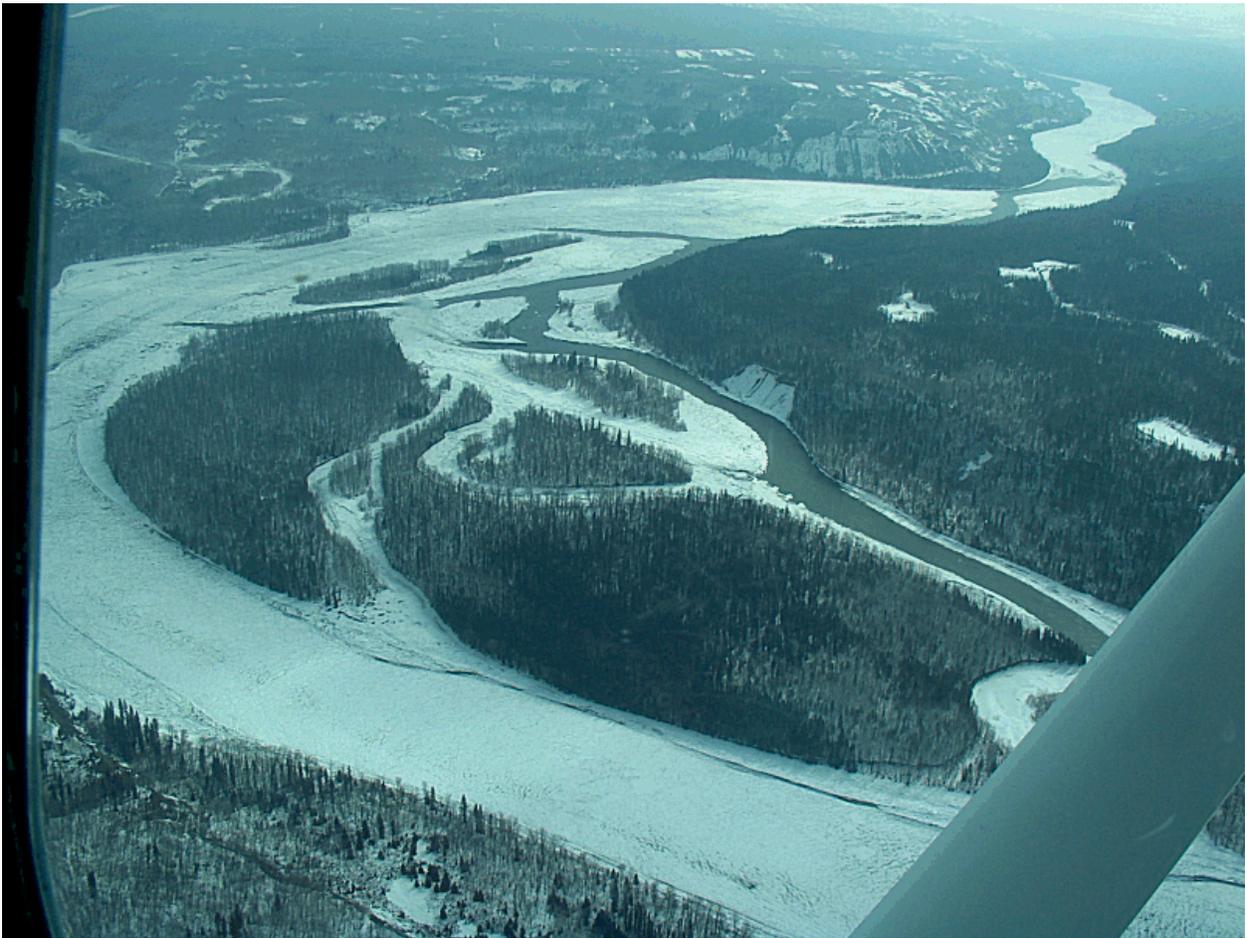
Open leads in right channel at Many Islands (km 224.5 to 229.0) and in main channel from km 229.0 to 231.7. (Looking downstream).

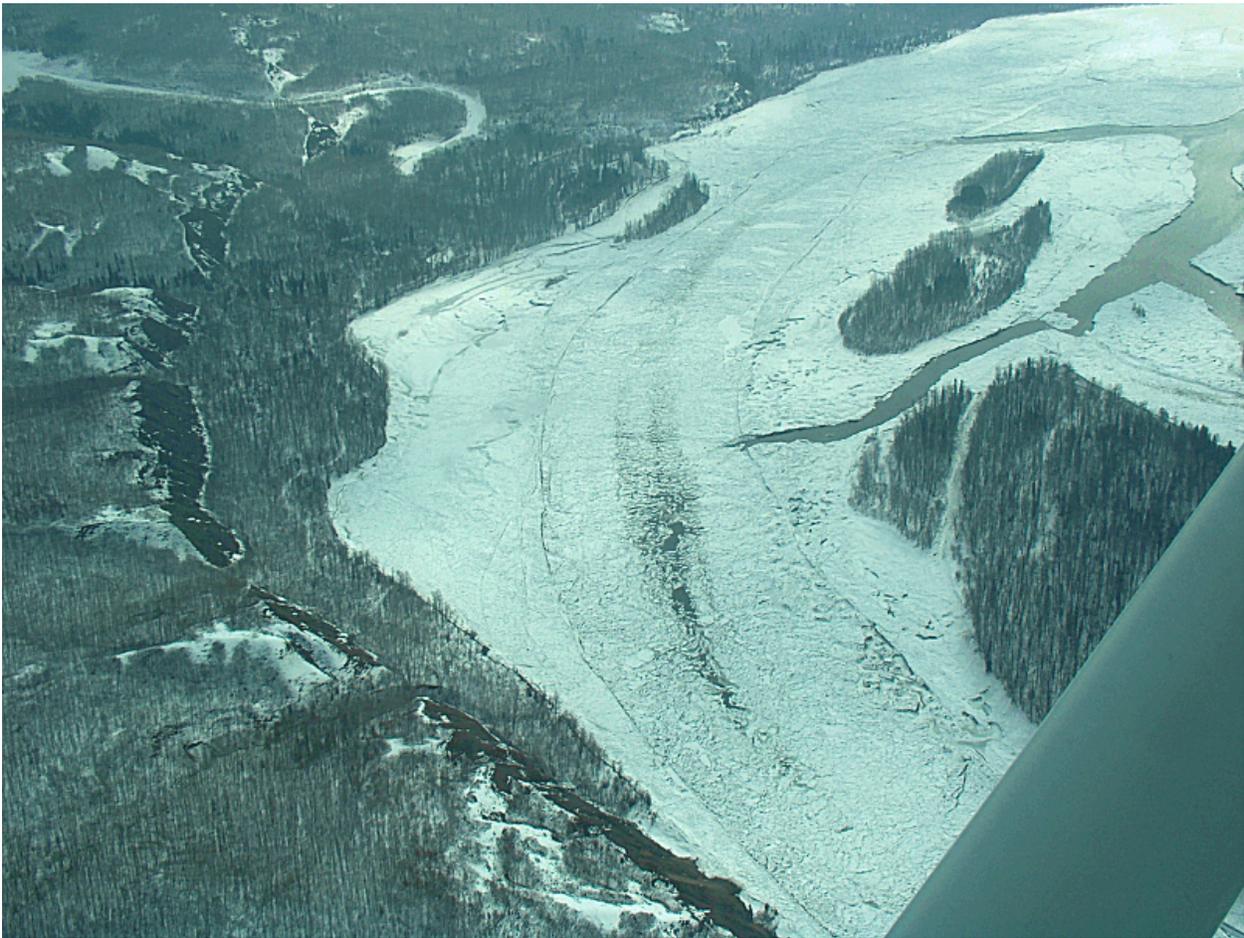
Narrow deteriorated cover in main channel at km 227 to 228.8 (Looking downstream). Leads in right channels at Many Islands

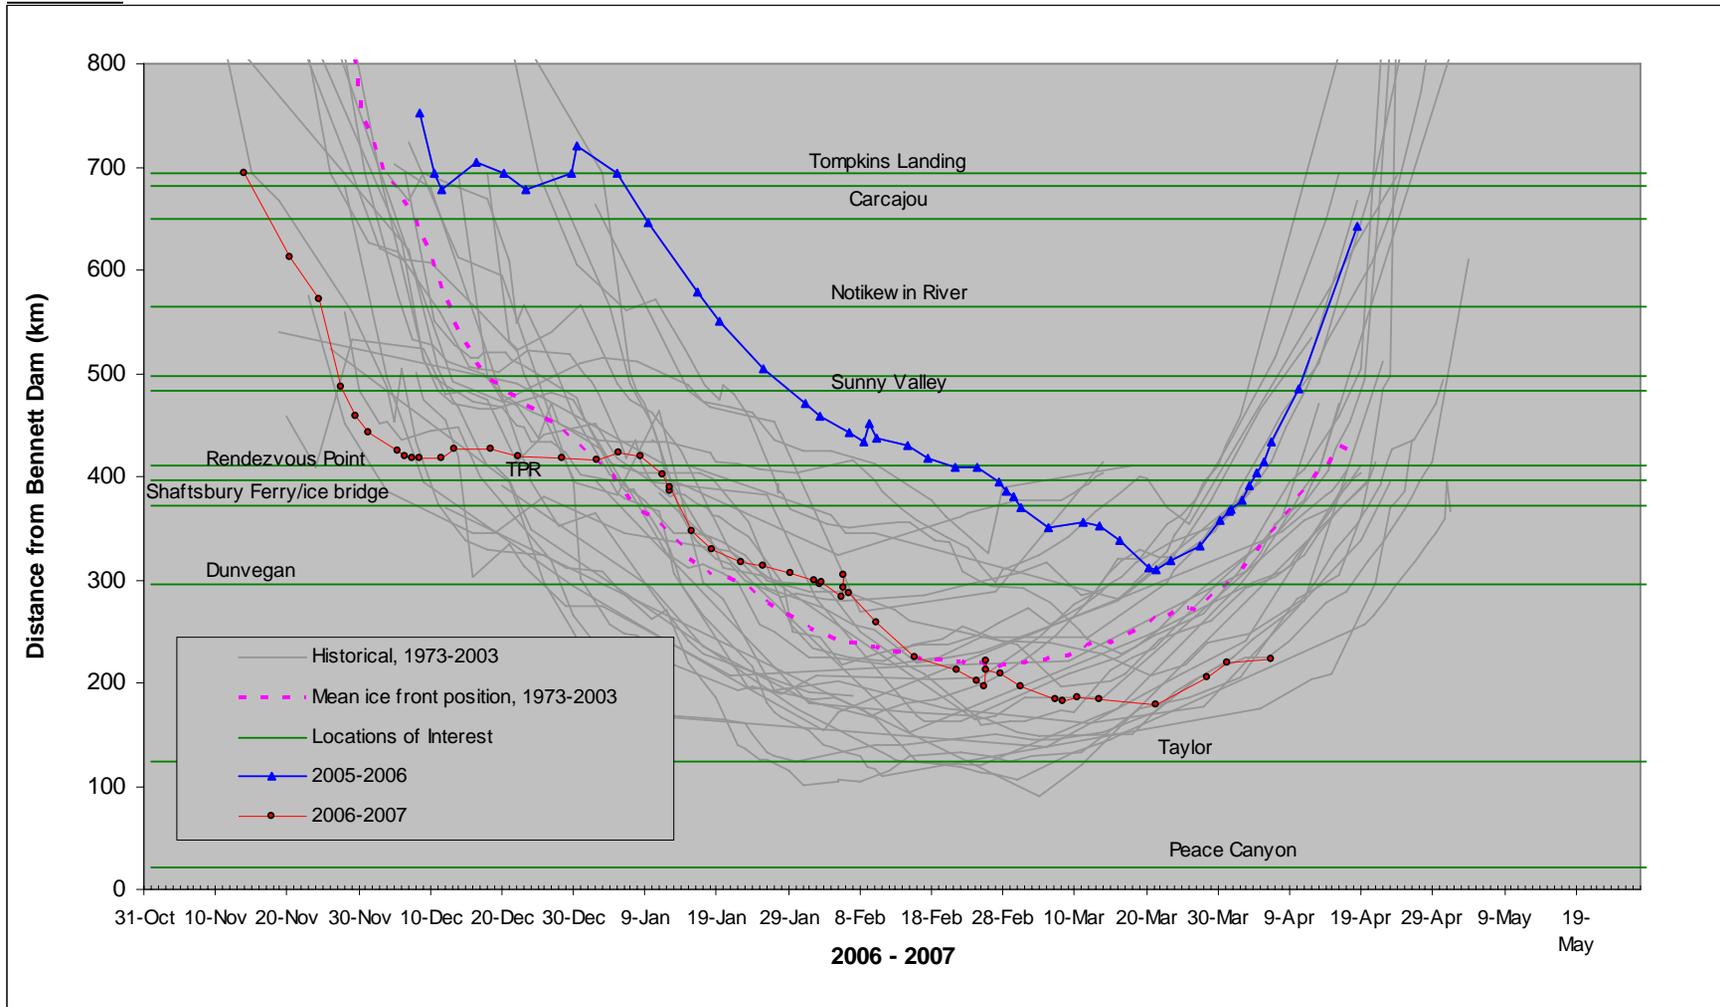
Ice Front

Location of the Ice Front: The ice front had receded 4.7 km downstream since the last observation on March 31 and was located at **km 223.5 on Apr 6, 2007, 10:30 MDT**. This was approximately 73 km upstream of Dunvegan or about 60 km downstream of the Clayhurst Bridge near the BC/AB border. The recession rate of the ice front between the last two observations was about 0.8 km/day. Since the last flight, daily low temperatures at the Fort. St. John Airport had been between -7 and -21 °C with daily highs between from 0 to -8 °C.
