2013 – 2014 Peace River Report No. 41

Observation Details

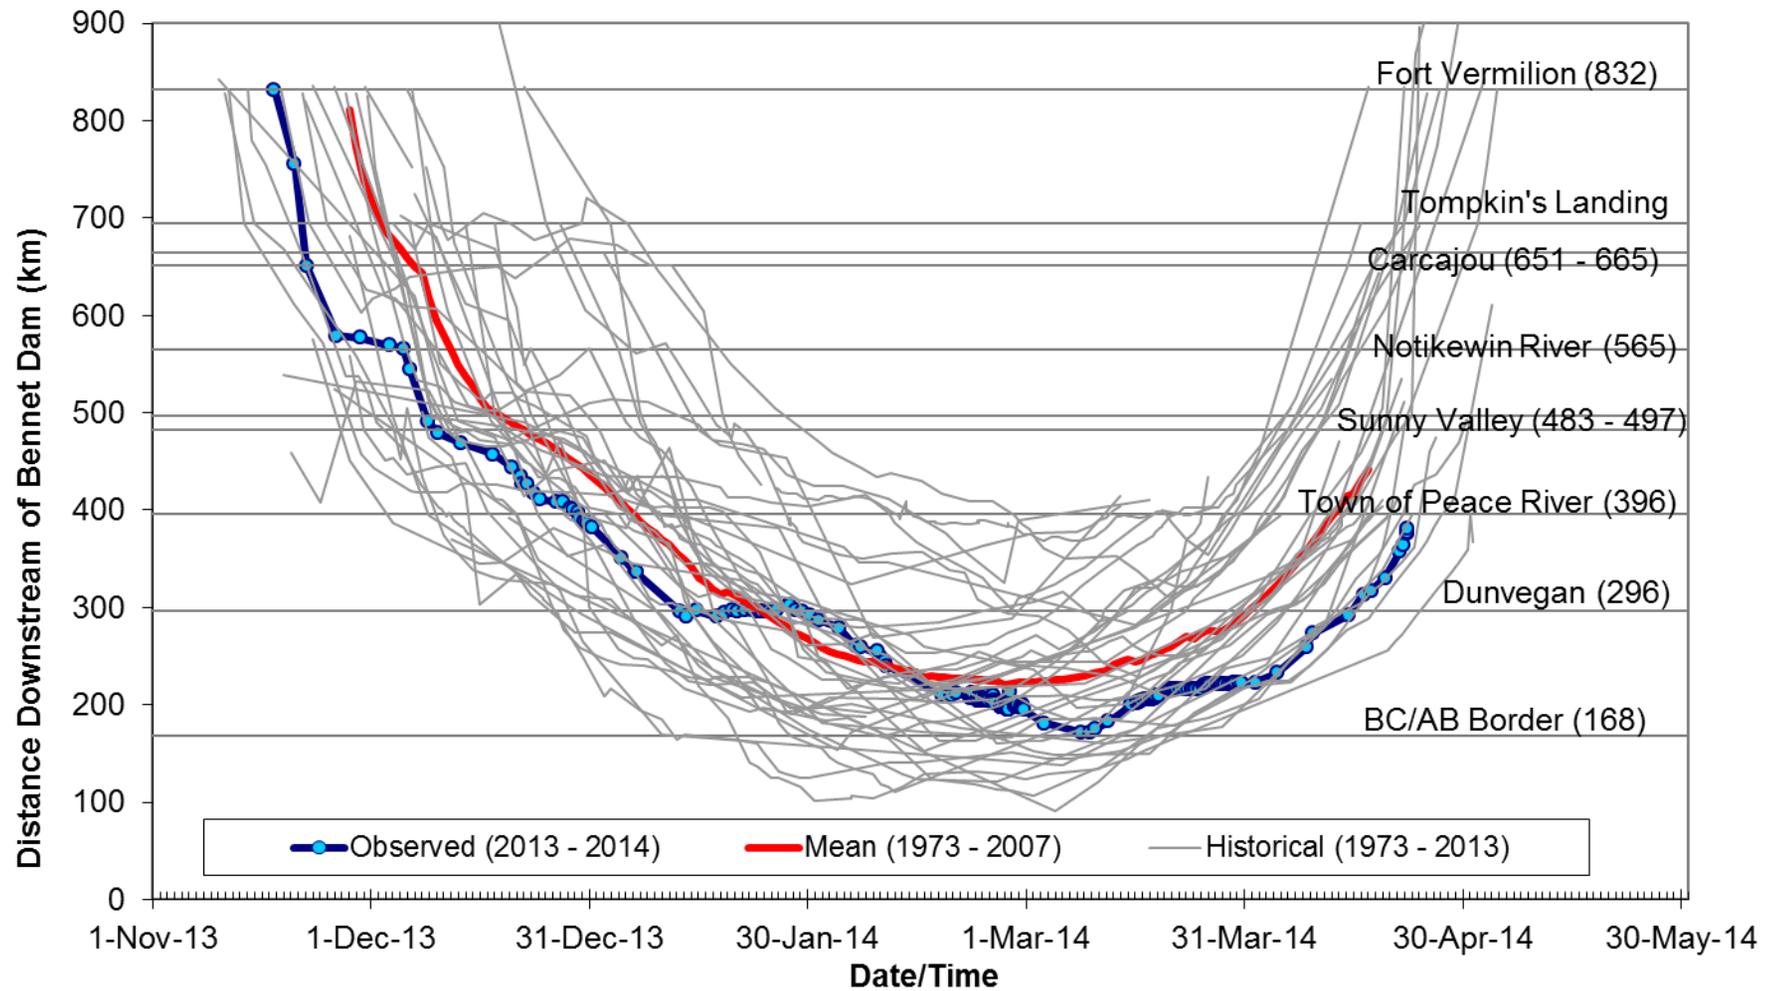
Observed Peace River Ice Front Locations 2013-2014

- Channel is clear from downstream of the Smoky River (km 388) to downstream of the DMI bridge (km 414).
- km 376 – Ice front at 8:04 MST.
- km 377.4 - Ice front at 9:32 MST.
- km 381 – Ice front at 11:00 MST (Correctional Institute).
