## 2014 – 2015 Peace River Report No. 27

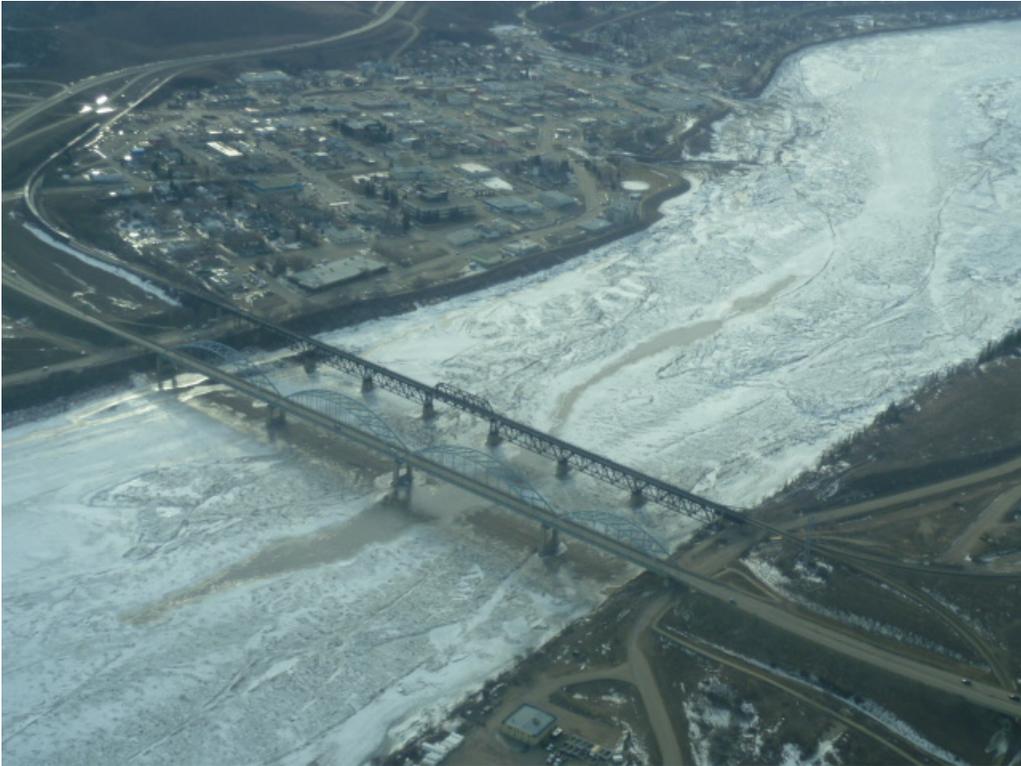
**Photo #1: The Hwy 2 and rail bridges over the Peace River in the Town of Peace River (km 396). Direction of flow is from right to left. March 20, 2015.**

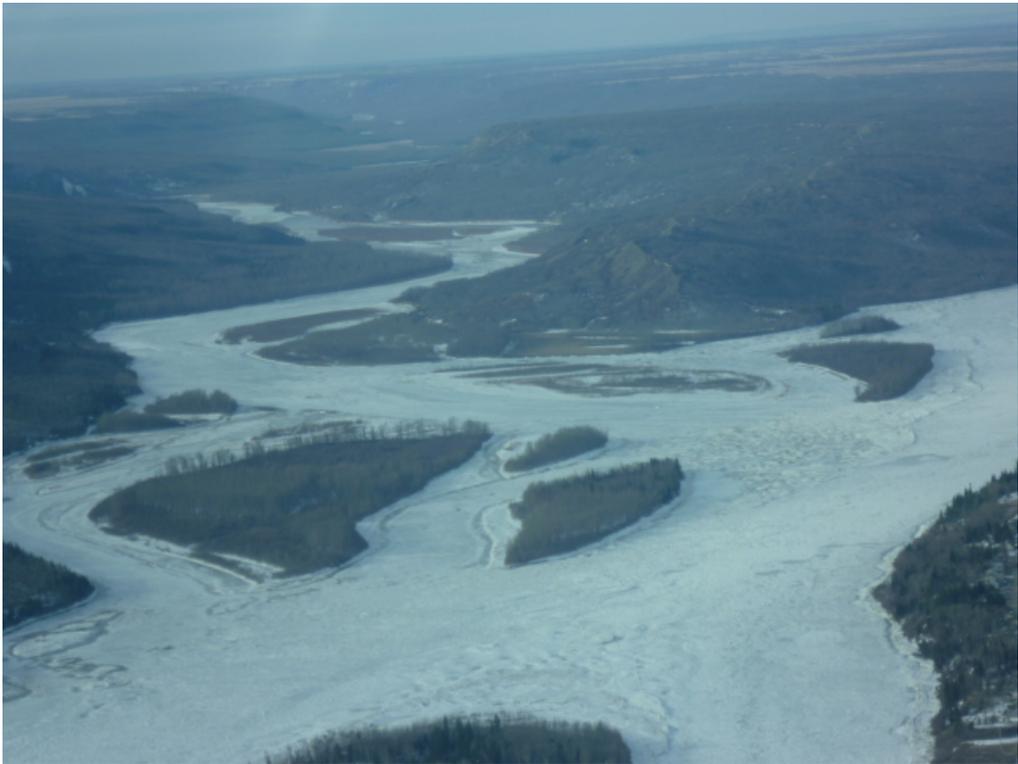
**Photo #2: Intact ice cover at confluence of the Peace (right) and Smoky (left) Rivers. The direction of flow is from top to bottom. March 20, 2015.**

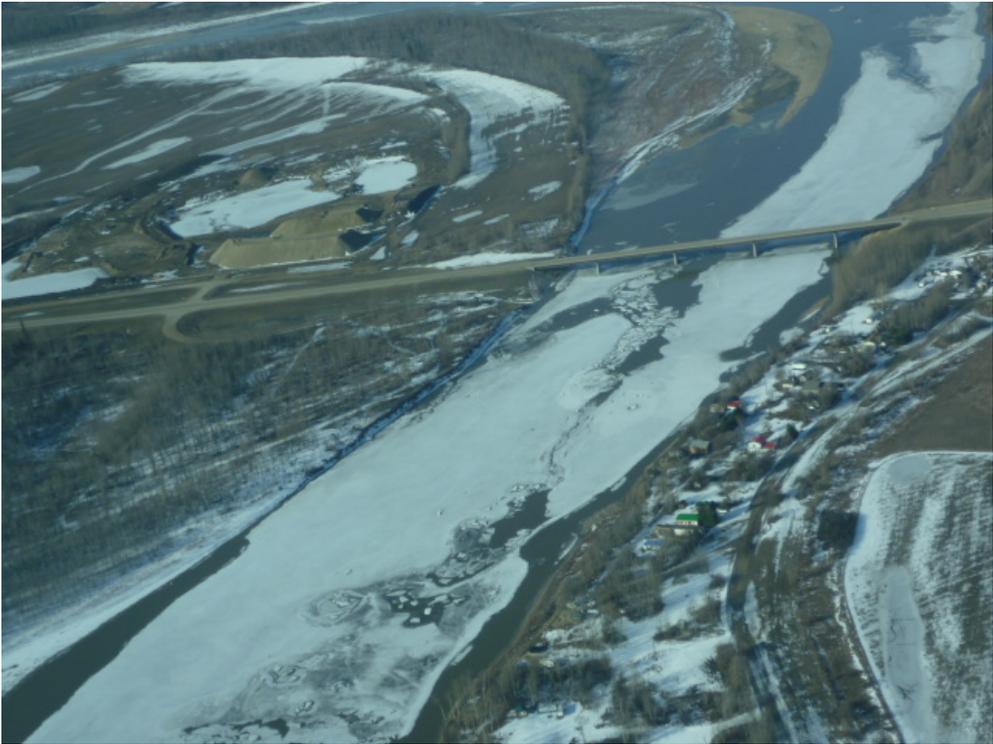
**Photo #3: Deteriorated ice cover at the Hwy 49 bridge crossing over the Smoky River at Watino. Direction of flow is from top to bottom. March 20, 2015.**

- Observations at the Hwy 49 bridge over the Smoky River at Watino (km 65) showed some ice pieces pushed up onto the existing ice cover, and open leads present. Remaining ice appear to be intact and water levels remain low.
- Observations at the Hwy 744 (km 24.5) over the Little Smoky River showed a localized breakup of the ice cover, with deteriorated brash ice melting in place. Remaining ice was dark in color.
- Observations at the Hwy 49 bridge (km 60.5) over the Little Smoky Rivers showed a deteriorated ice cover, with water ponded on the ice surface. Open leads present.

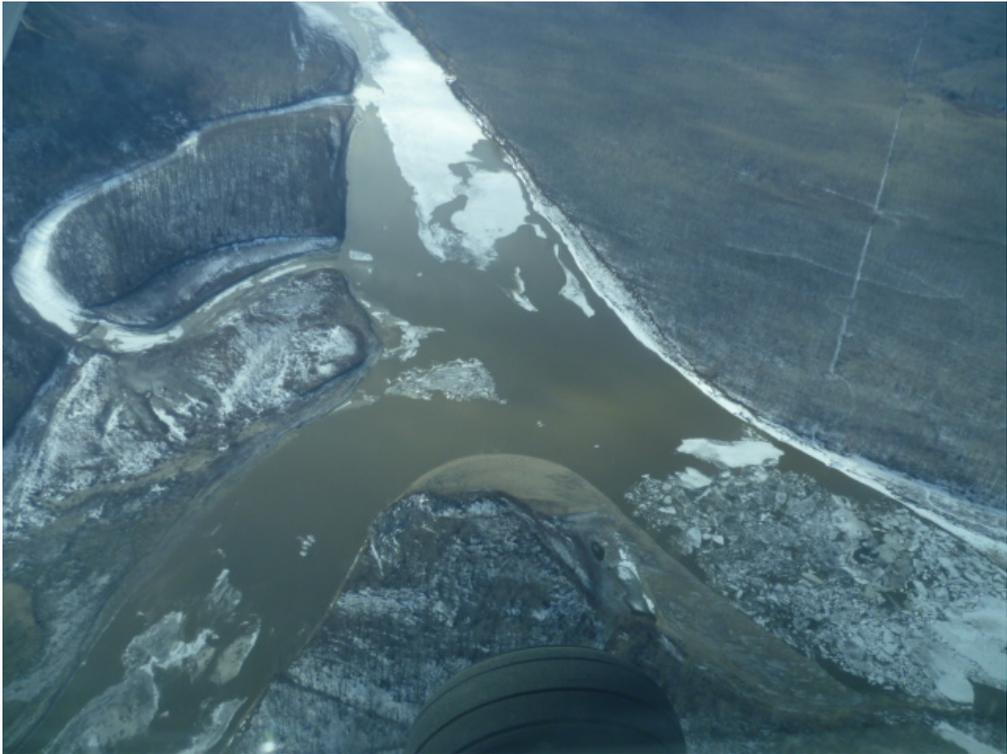
**Photo #4: Confluence of the Little Smoky (left) and Smoky (right) Rivers. Direction of flow is from left and top, respectively. March 20, 2015.**
